MONITORING REPORT

COMMON INDICATOR 16

KARABURUN-SAZAN MPA

Vlore, 2022

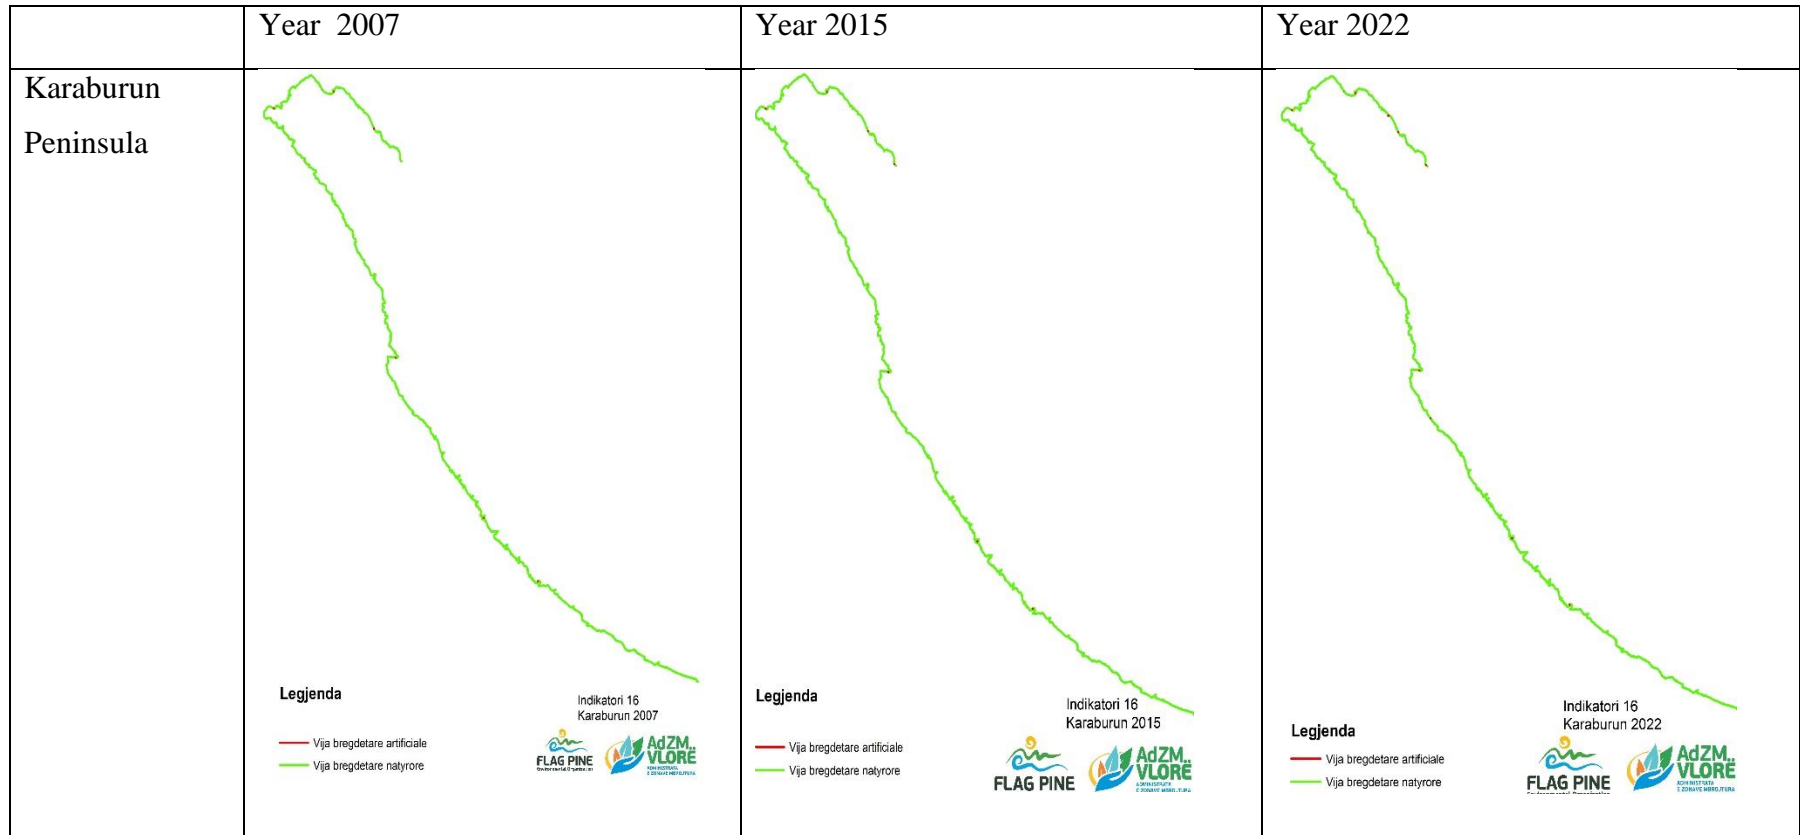
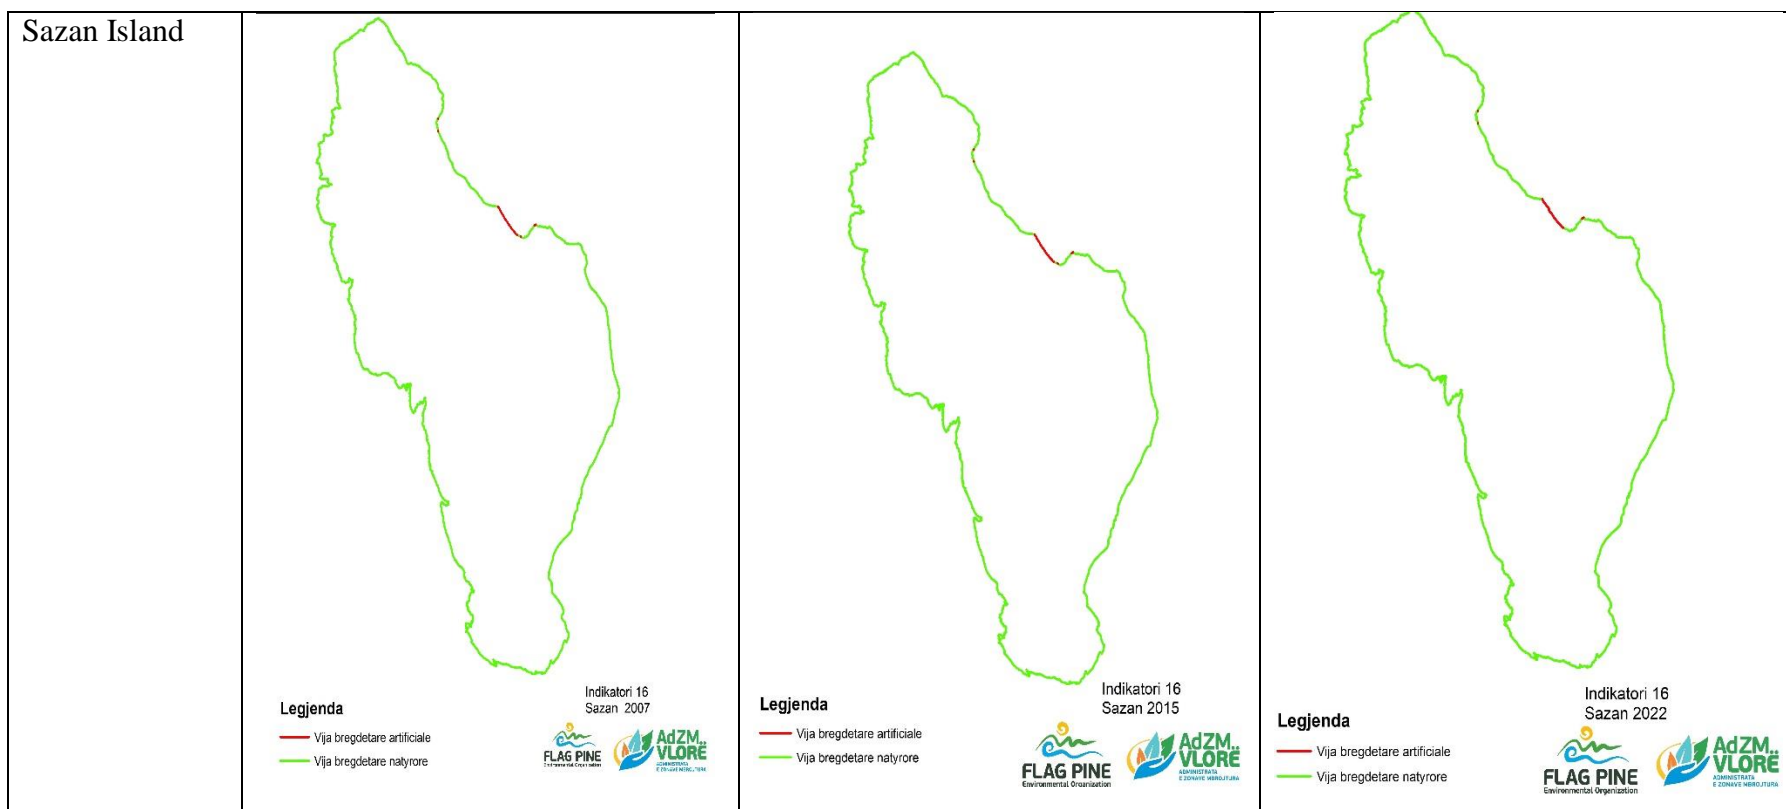
Figure 5. Indicator 16 in Karaburun-Sazan MPA for the year 2007, 2015, 2022

As shown in the Figure 5 the artificial structures, respectively, tunnel, docks, marinas and jetties for the year 2007 and 2015 are located in Shën Vasili Bay, the area between Shën Vasil and Dhimkushtë, Shën Jan Bay, Galloveci Cape, Moli i Veriut, Brisan Bay, Inglezi Bay, Grama Bay

and Sazan Island. In 2022, there is another intervention in the coastal area of Dhimkushta where the rock was transformed for the placement of umbrellas and also a dock was built for the anchorage of boats.

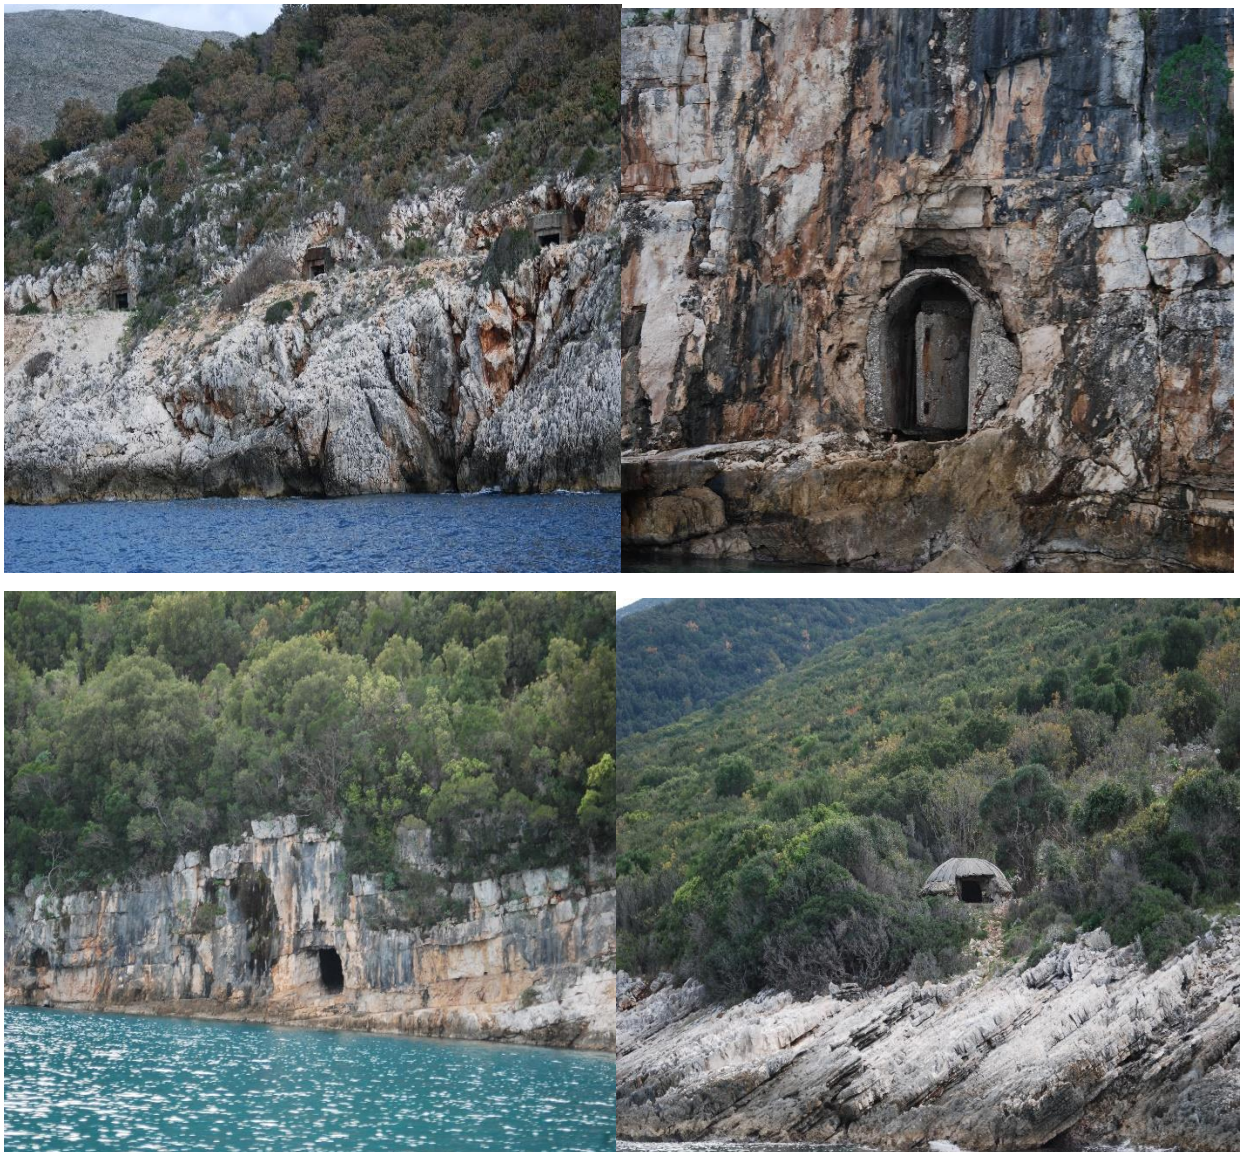
Figure 6. Photos of man-made structures inside the 100m area.

Respectively the number of bunkers is 84, the number of docks and jetties is 15, the number of unknown buildings is 47, storage buildings 1, lighthouse 2, church 1 and hut 2. The surface of the land covered by this structures is shown in Graph 3 where the most of the land is claimed by buildings whose function isn't known by 5081m², moreover the highest surface covered is by docks and jetties, respectively 7123m².

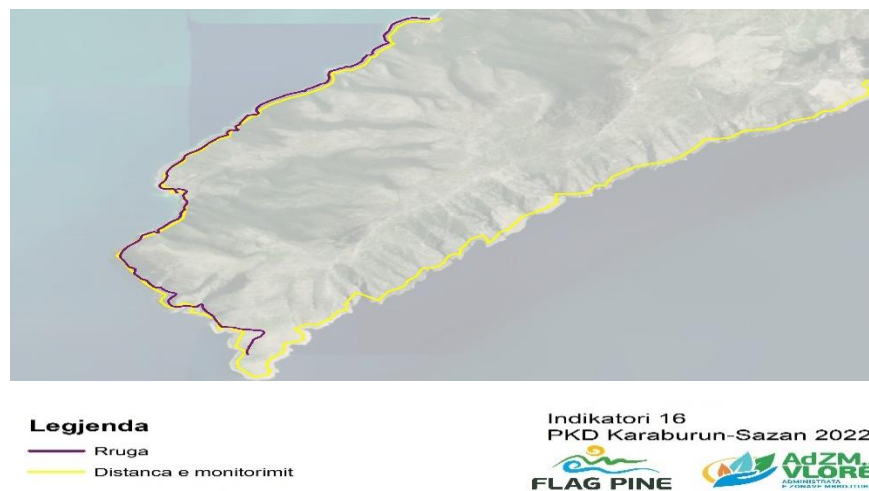
Another element that shows the anthropogenic impact is also the existence of a terrestrial road that is being used by the military base and management authorities for patrolling. The road, as seen in Figure 7 sometimes falls inside the 100m area and some times is out of it. All the man-made infrastructures are shown in the map in Figure 8.

Figure 7. The extension of the military road within the monitoring area.

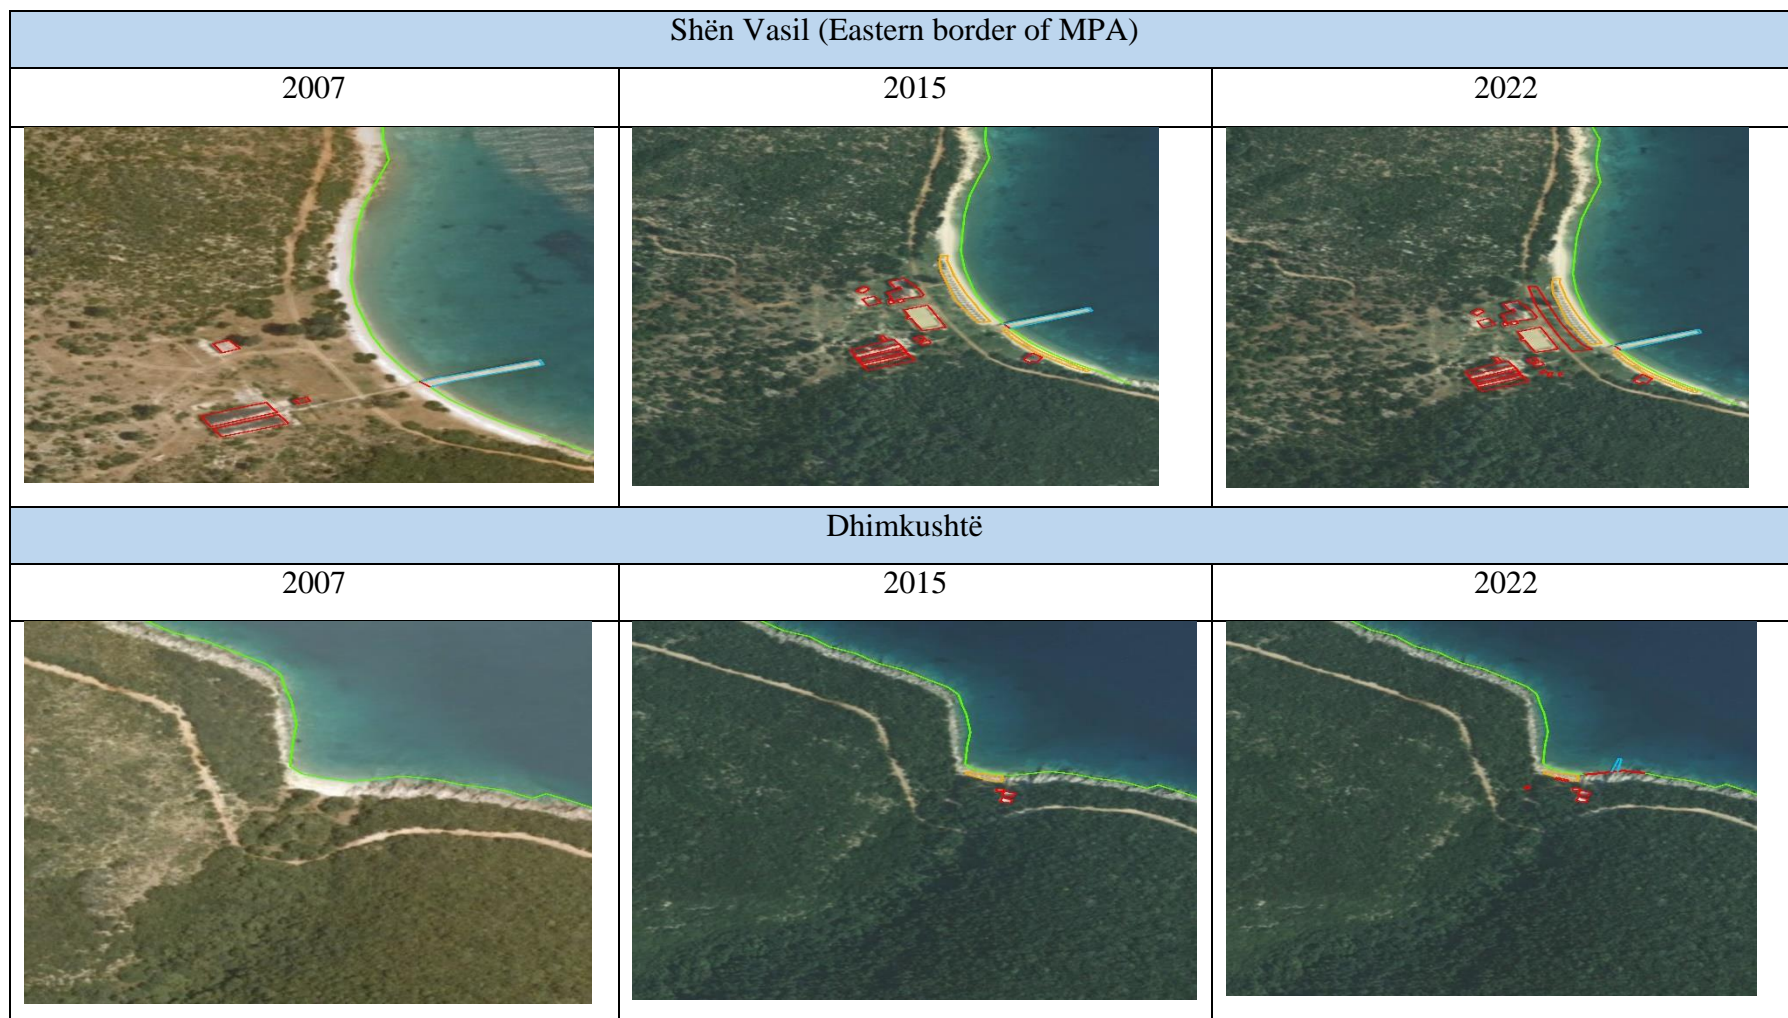
Figure 9. Changes in the infrastructure of the beaches of Karaburun-Sazan MPA from 2007 to 2022.

Major changes are made in the beaches of Shën Vasil and Dhimkushtë meanwhile smaller changes are made in Grama Bay and Shën Jan Bay. Must be taken into consideration that Shën Vasil bay, located in the eastern side, is not part of Karaburun-Sazan MPA but due to its vicinity with the park is considered as part of it. In addition, another area that is located in the western border of the MPA, Palasa Bay has undergone major changes, shown in Figure 10. The changes noticed in these areas confirm even more the increased pressure for the artificialisation of the coastal areas.

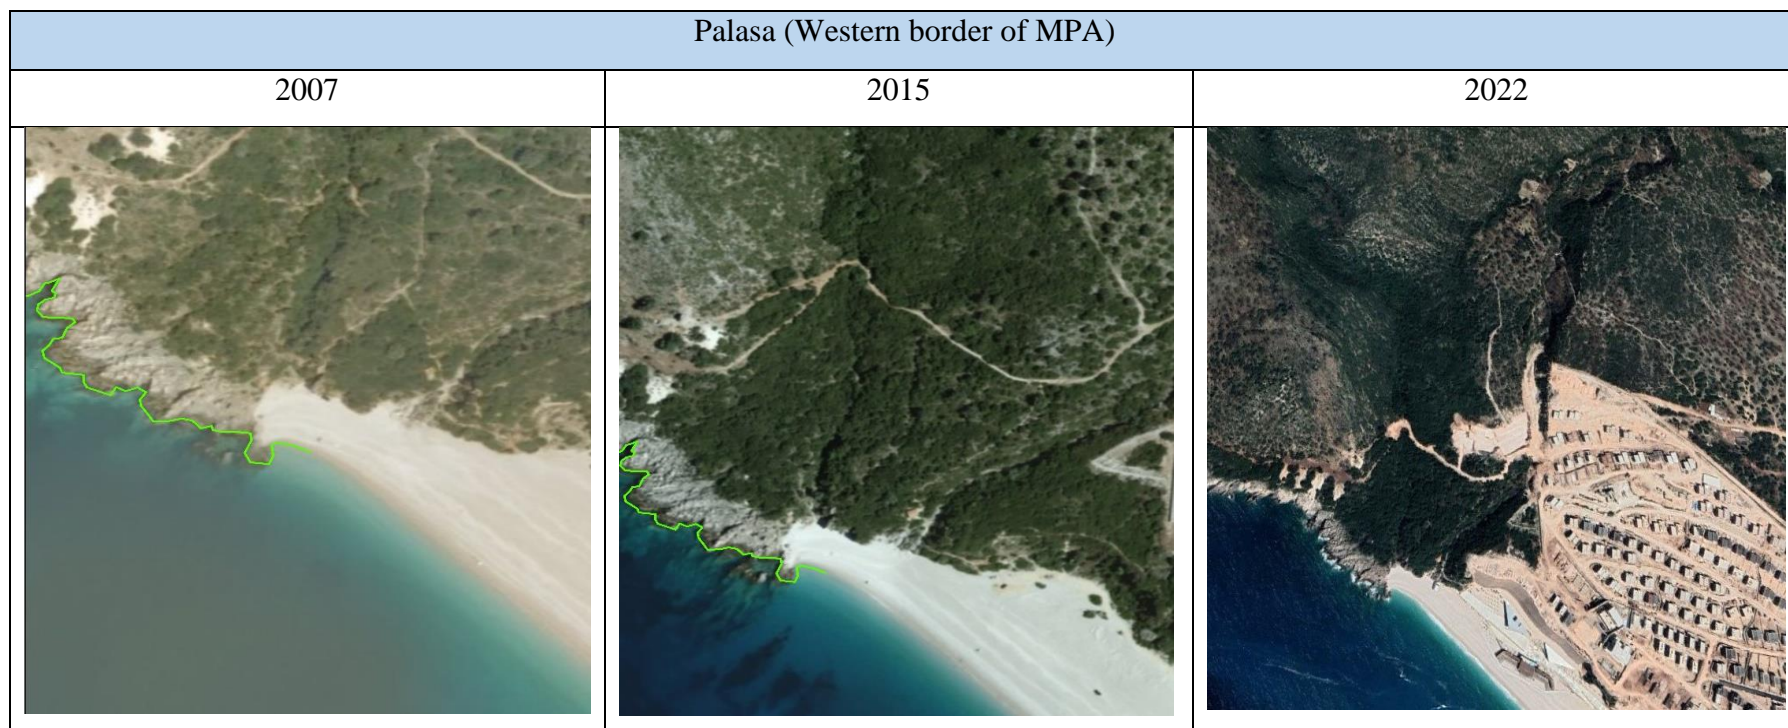
Figure 10. Changes in the infrastructure in the coastal area of the western border of the MPA.

In the other bays of the MPA, located in the western side of Karaburun Peninsula, the situation remains the same as during the communism period apart from Brisán bay where small infrastructure has taken place, as shown in Figure 11. In Sazan Island also there are not made major changes apart from some small building in the upper area of the monitoring zone.

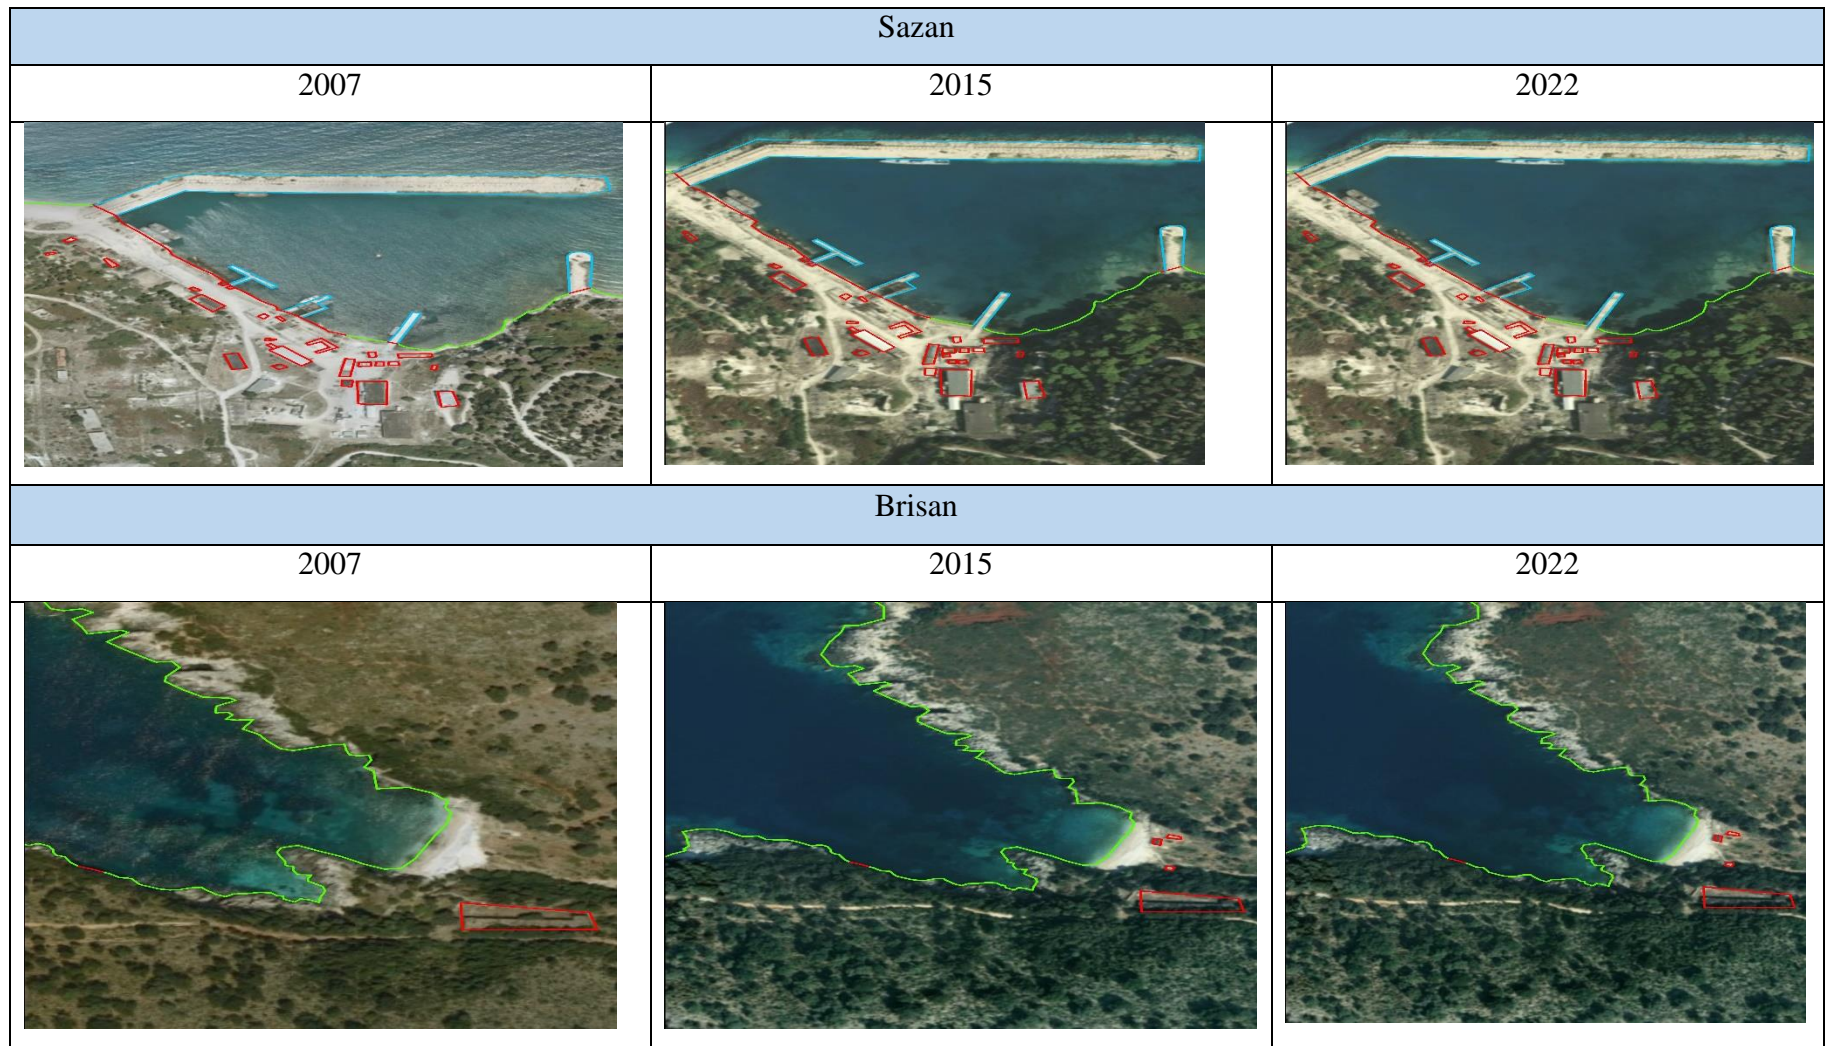
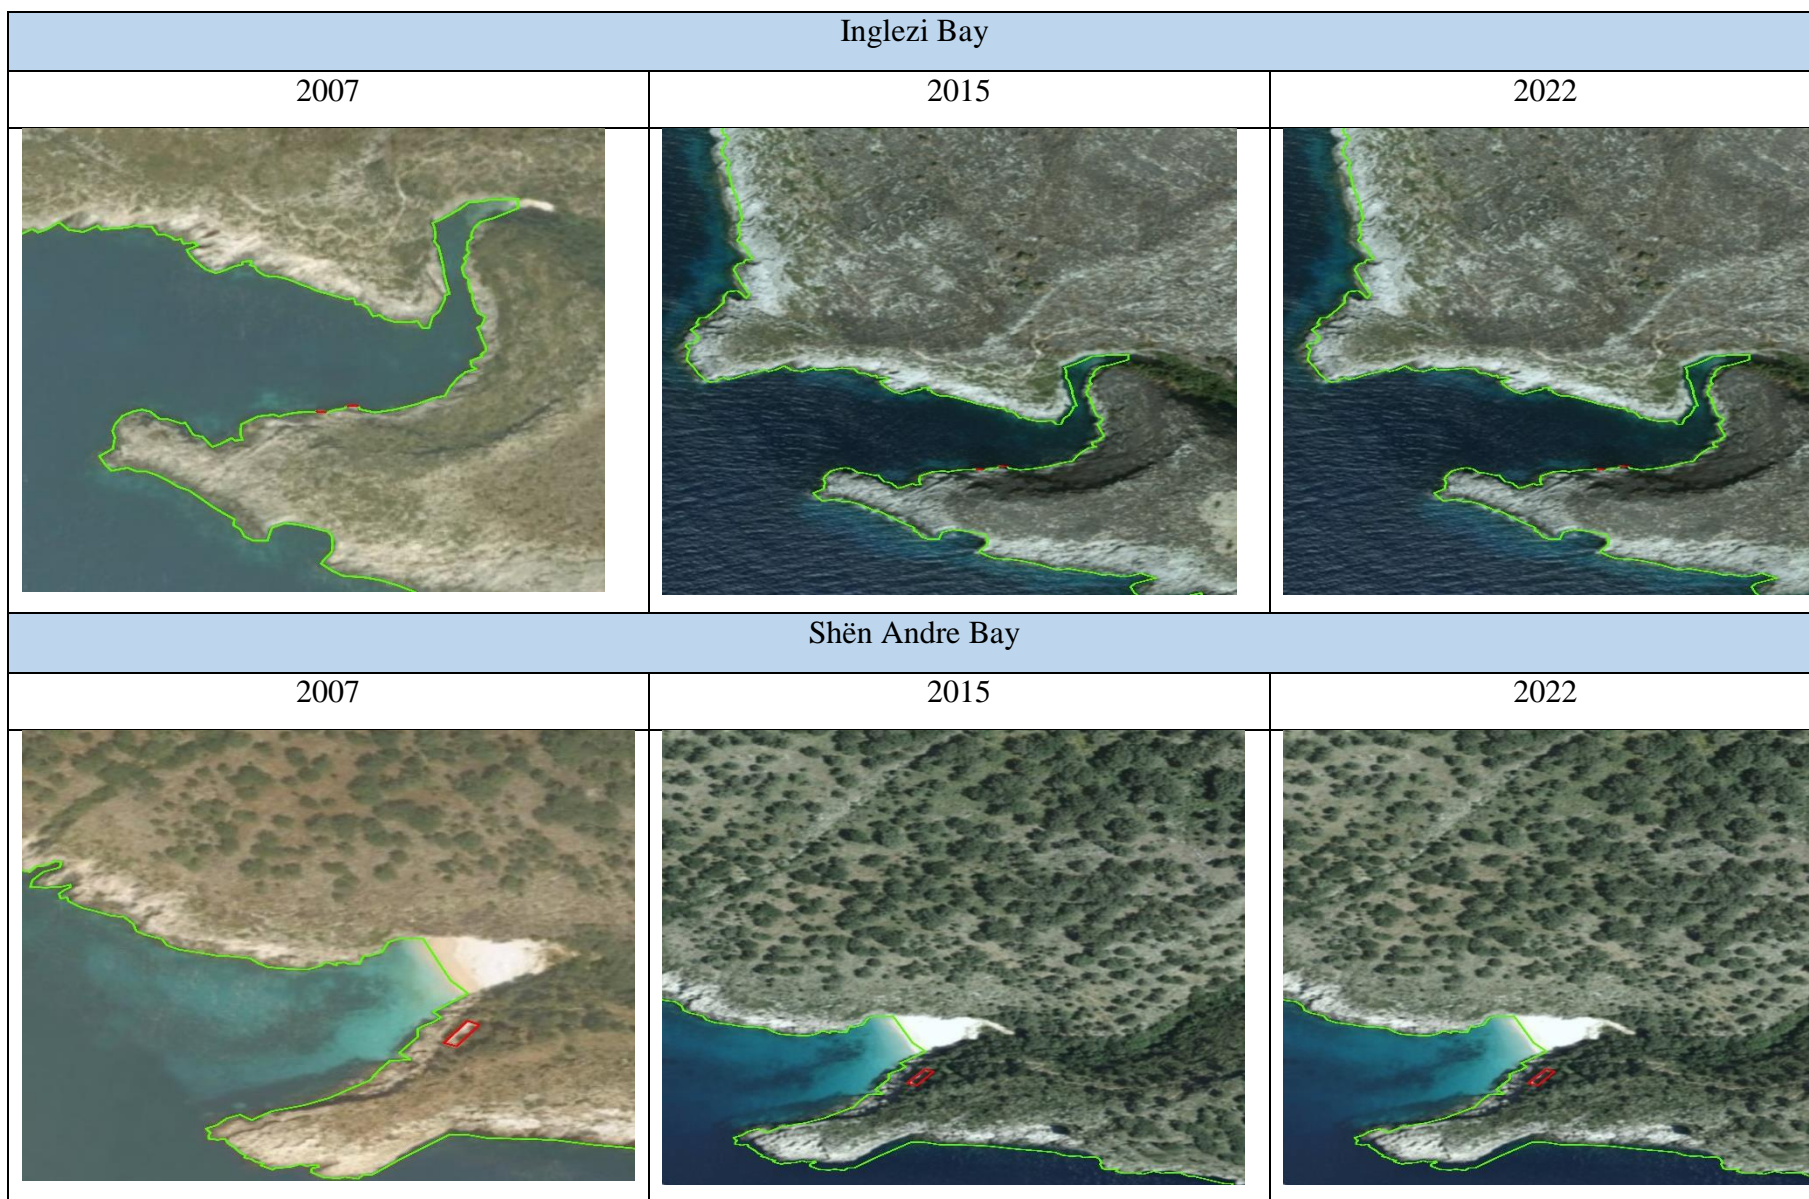
Figure 11. Situation in Sazan Island and the beaches in the western side of Karaburun-Sazan MPA.
