MONITORING REPORT

COMMON INDICATOR 16

KARABURUN-SAZAN MPA

Vlore, 2022

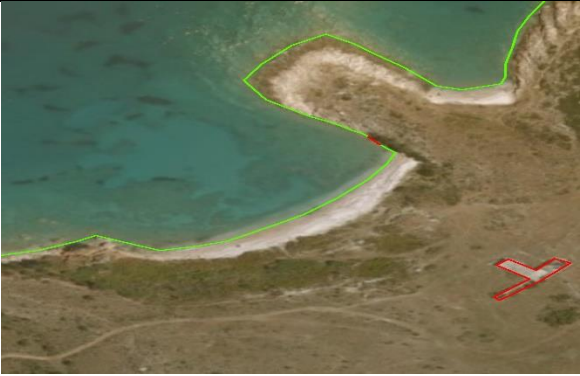
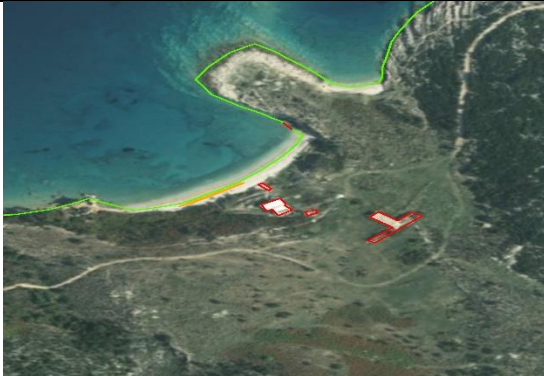
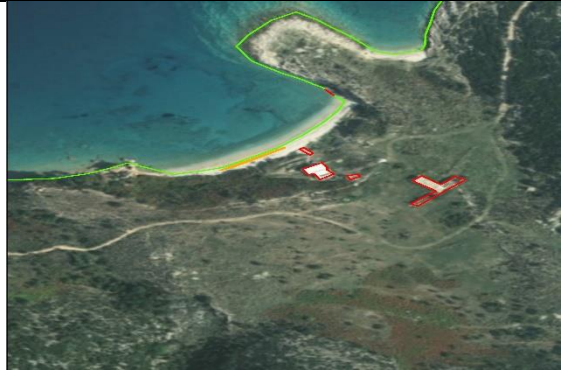
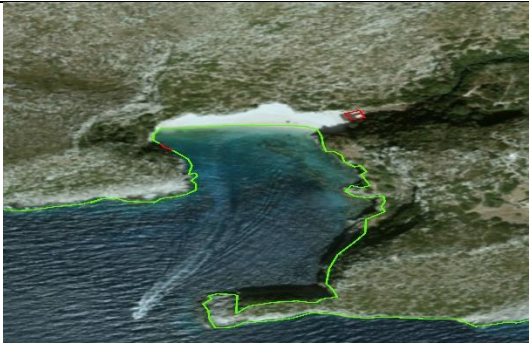
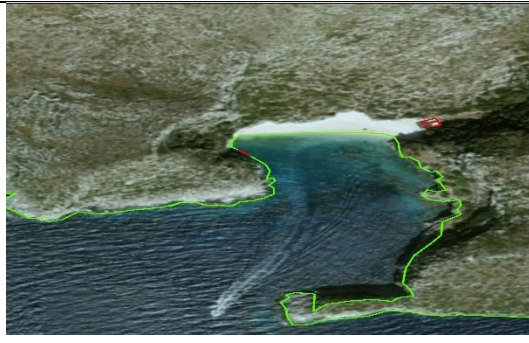
Figure 9. Changes in the infrastructure of the beaches of Karaburun-Sazan MPA from 2007 to 2022.

In 2015, which marks also the year of the proclamation of the marine park, the interest of the area for tourism activities arises and as a result, four service points were built in Shën Vasil Bay, Dhimkushta Bay, Shën Jan Bay and Grama Bay. At the beginning, as shown in Figure 9 the infrastructure in these service points was quite minimal but in 2022 the situation is much more different.

Major changes are made in the beaches of Shën Vasil and Dhimkushtë meanwhile smaller changes are made in Grama Bay and Shën Jan Bay. Must be taken into consideration that Shën Vasil bay, located in the eastern side, is not part of Karaburun-Sazan MPA but due to its vicinity with the park is considered as part of it. In addition, another area that is located in the western border of the MPA, Palasa Bay has undergone major changes, shown in Figure 10. The changes noticed in these areas confirm even more the increased pressure for the artificialisation of the coastal areas.
